J-2183-08

Re: Former Unimar Site  
6701 Fox Avenue South  
Seattle, Washington

Attached are photographs of the excavation area on the referenced property where approximately 150 cubic yards (CY) of additional soil/sand waste contaminated with metals was removed. The soil was stockpiled on the site and later transported to Cedar Hills Landfill on October 24, 1990, by Olympus Environmental.

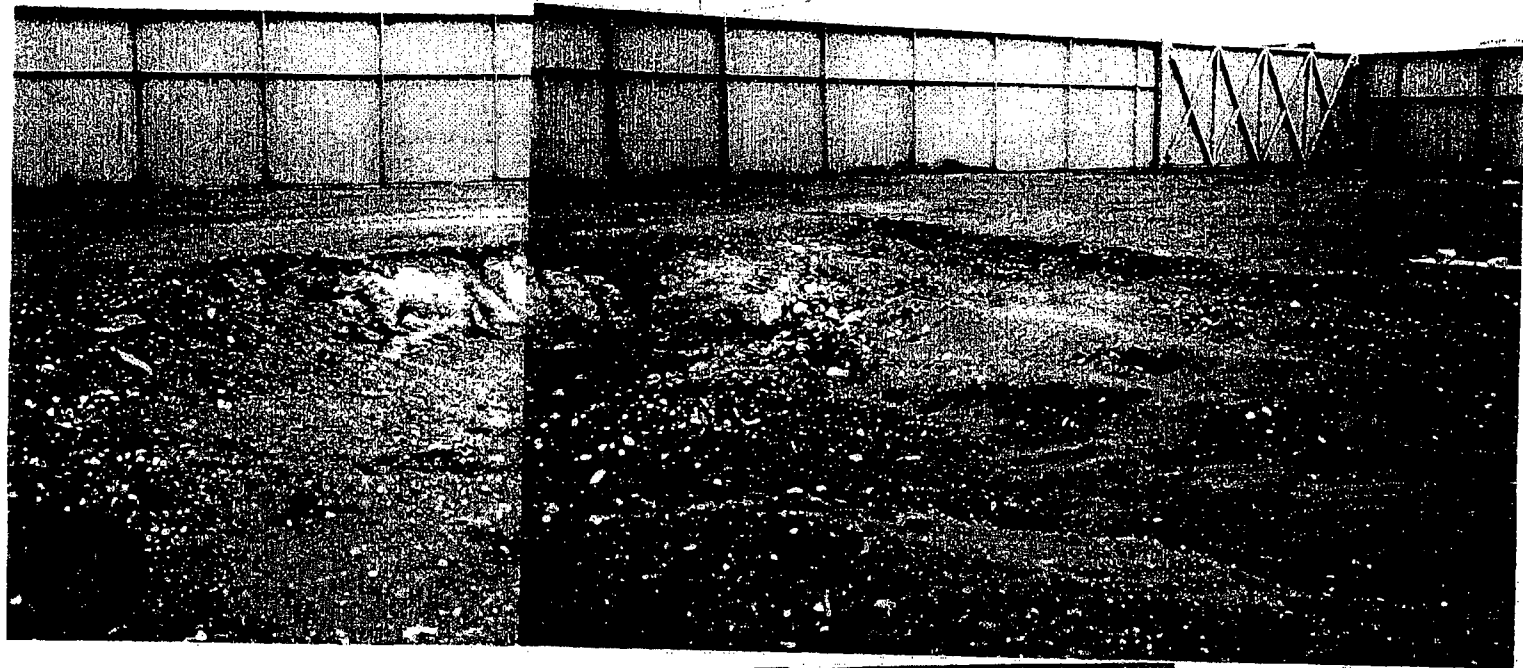
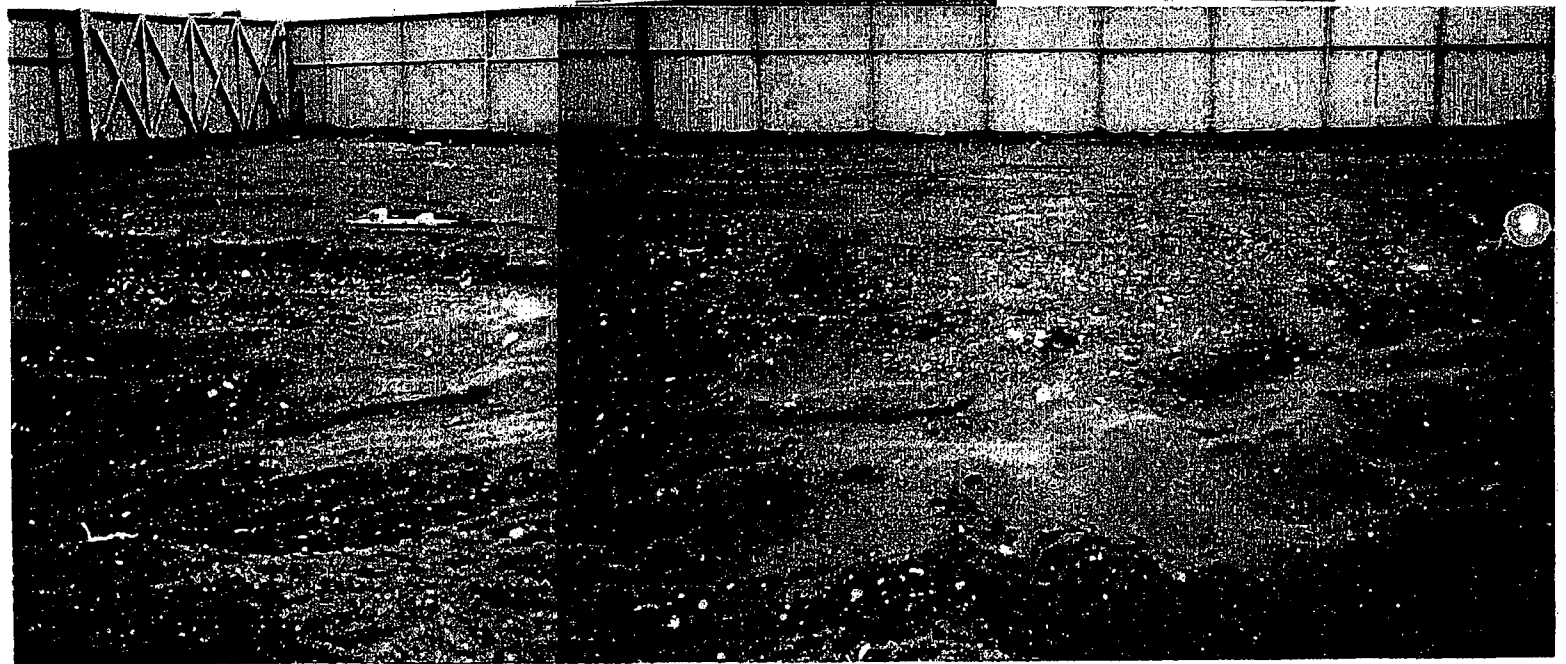
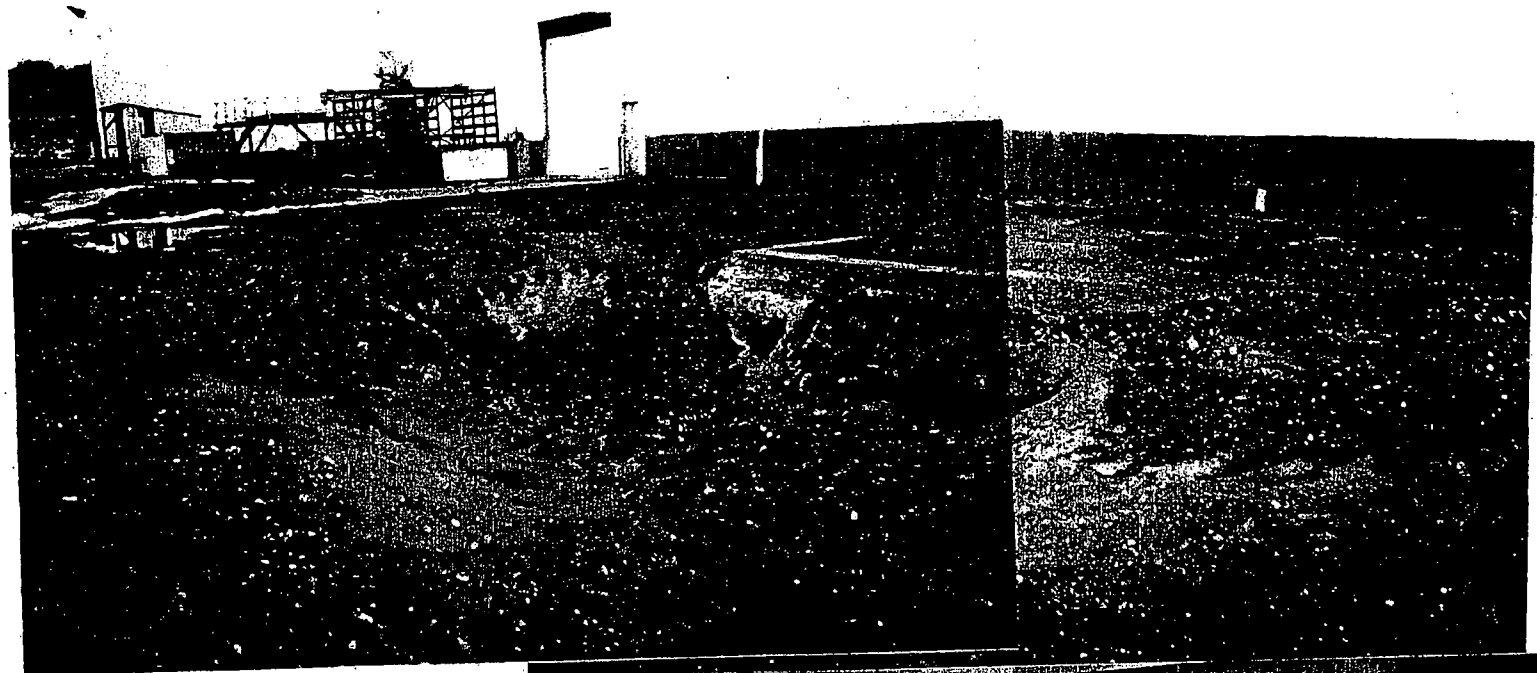
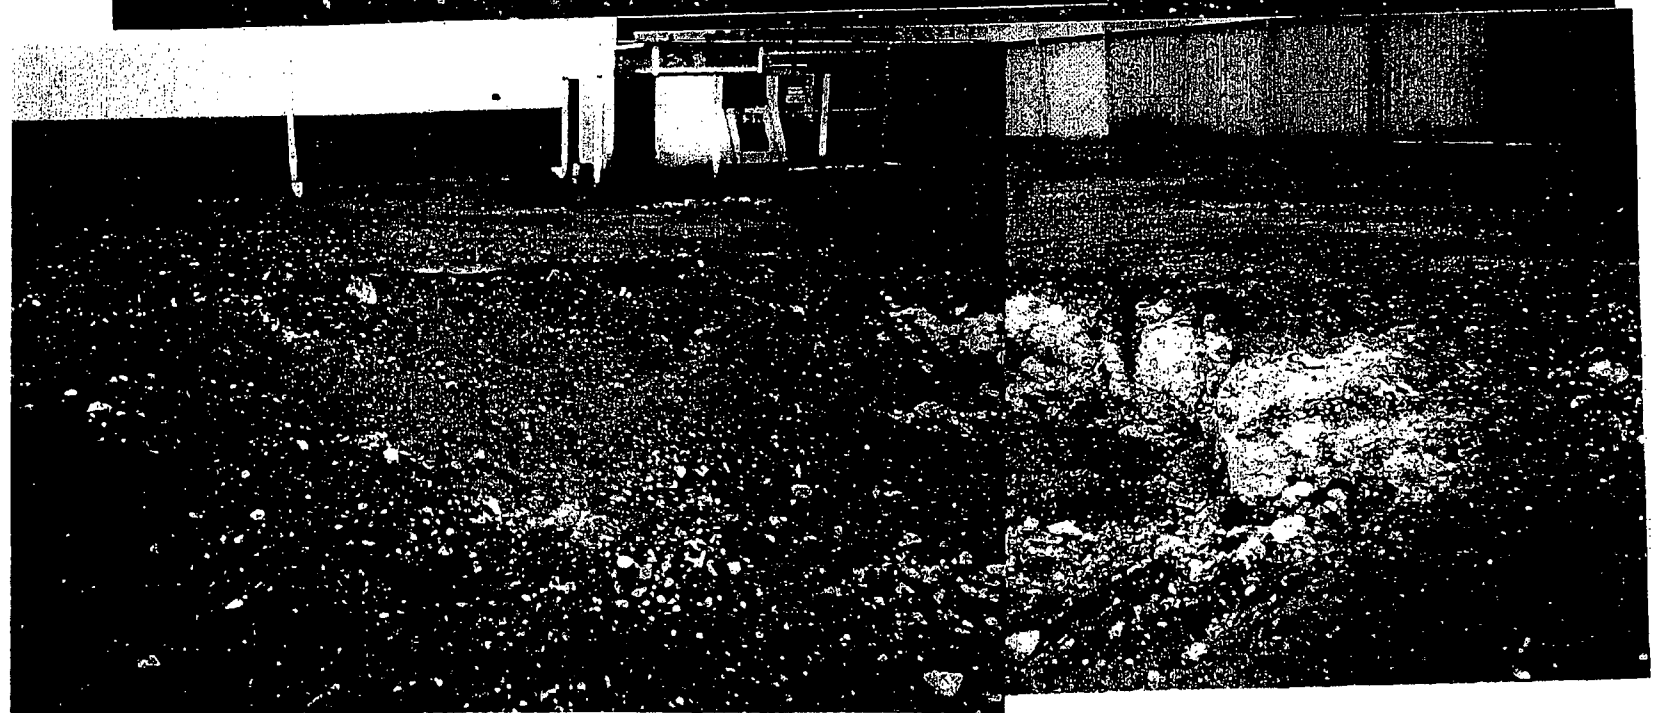
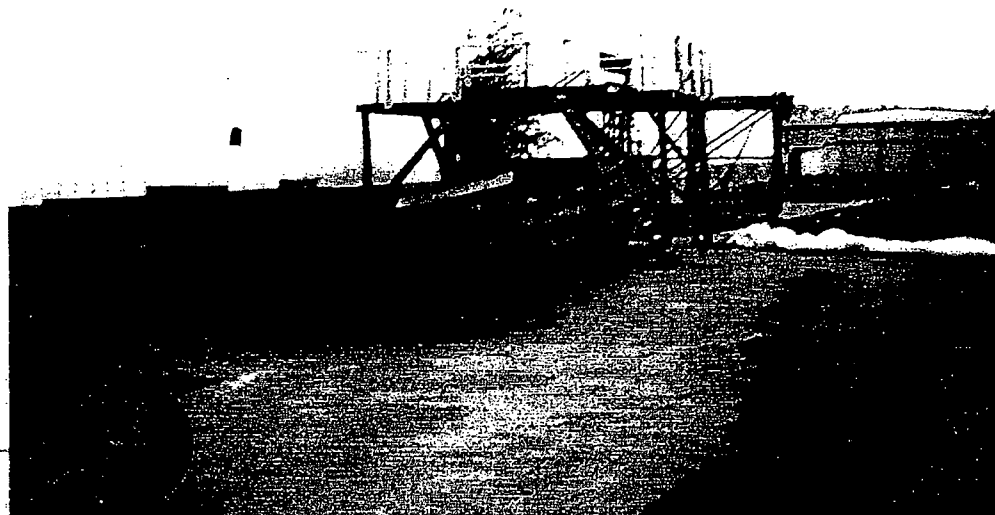
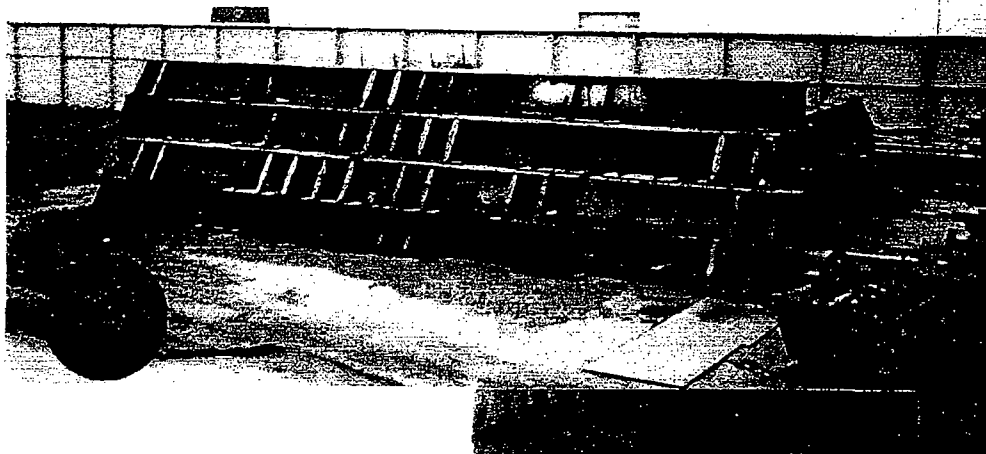
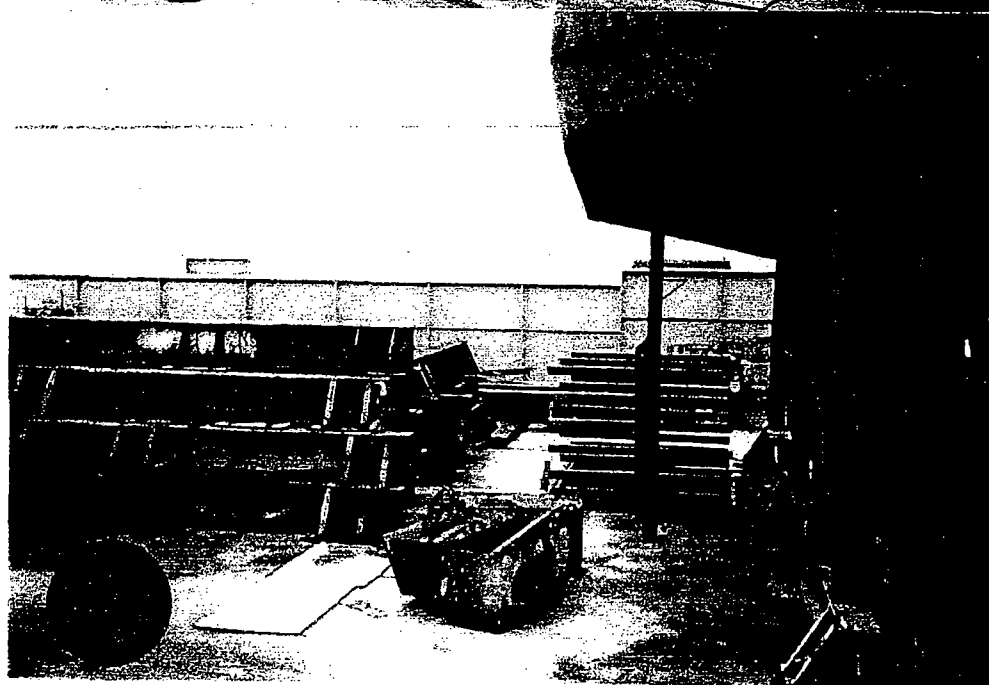
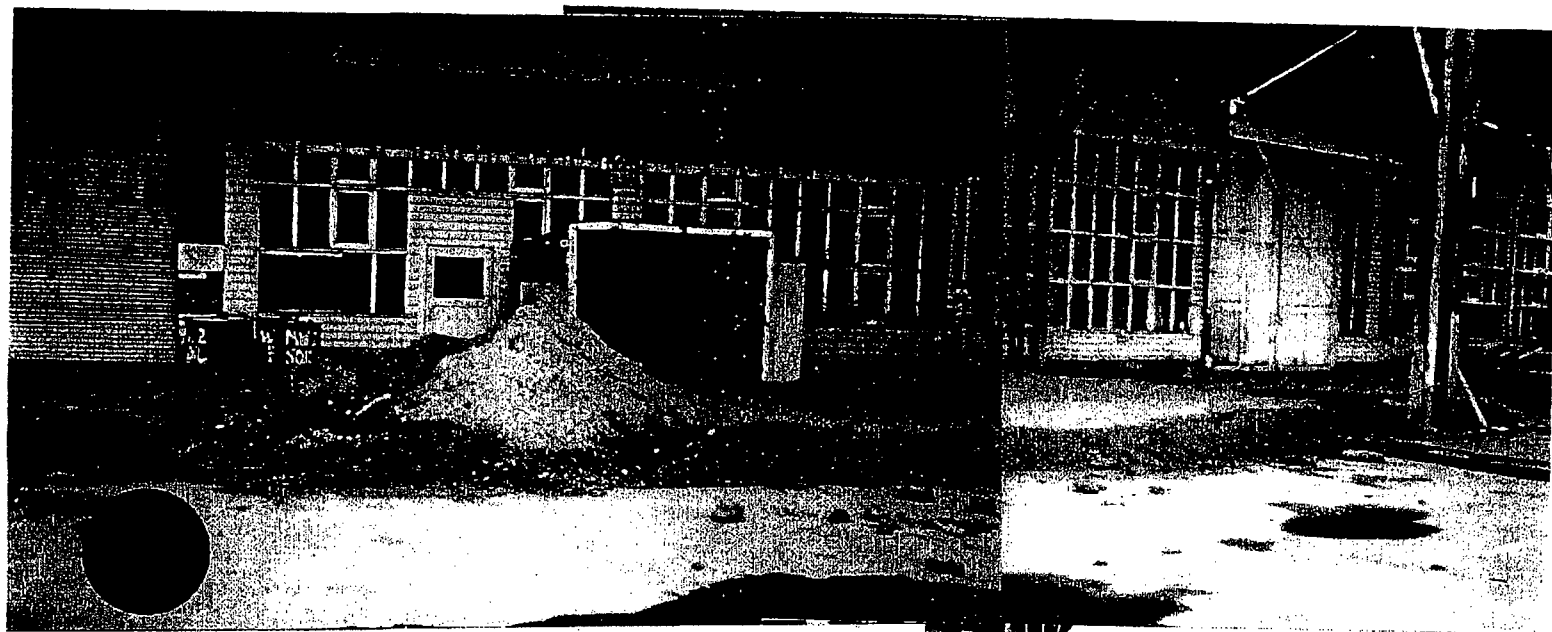
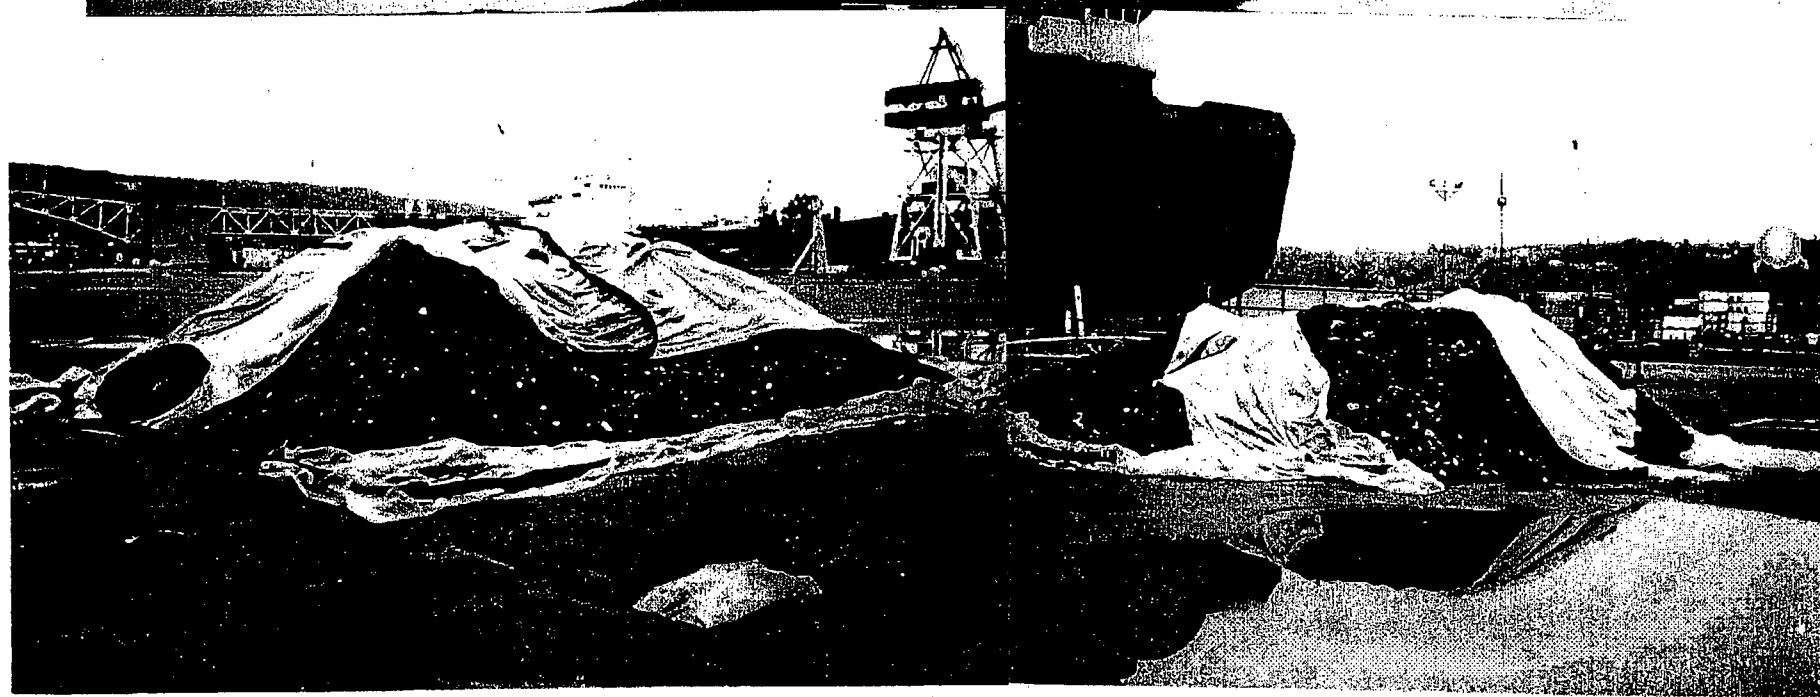
Photo Number

- 1 SE View of excavation area - note concrete mass
- 2 SW View of excavation area
- 3 NW View of excavation area - note footing
- 4 NE View of excavation area
- 5 } Steel beams, frames, girders, etc.  
6 } that were moved to allow excavation  
7 } and grading of storage area
- 8 Bio treatment pile - soil from tank excavation area
- 9 Excavated Soil - West View - Soil contains metals (As: 1300 ppm; Cr: 1300 ppm; Pb: 1100 ppm; and Hg: 200 ppm) - old paint waste
10. South view - excavated soil

The excavation area was backfilled with soils from the bio-treatment area (Photograph 8) and with a clean sandy fill acquired from West Seattle. The site was graded using the imported fill soil to level the area.
